NATIONAL ADVISORY COMMITTEE FOR AERONAUTICS

No. 1573

FLIGHT MEASUREMENTS OF THE FLYING QUALITIES OF
FIVE LIGHT AIRPLANES

By Paul A. Hunter

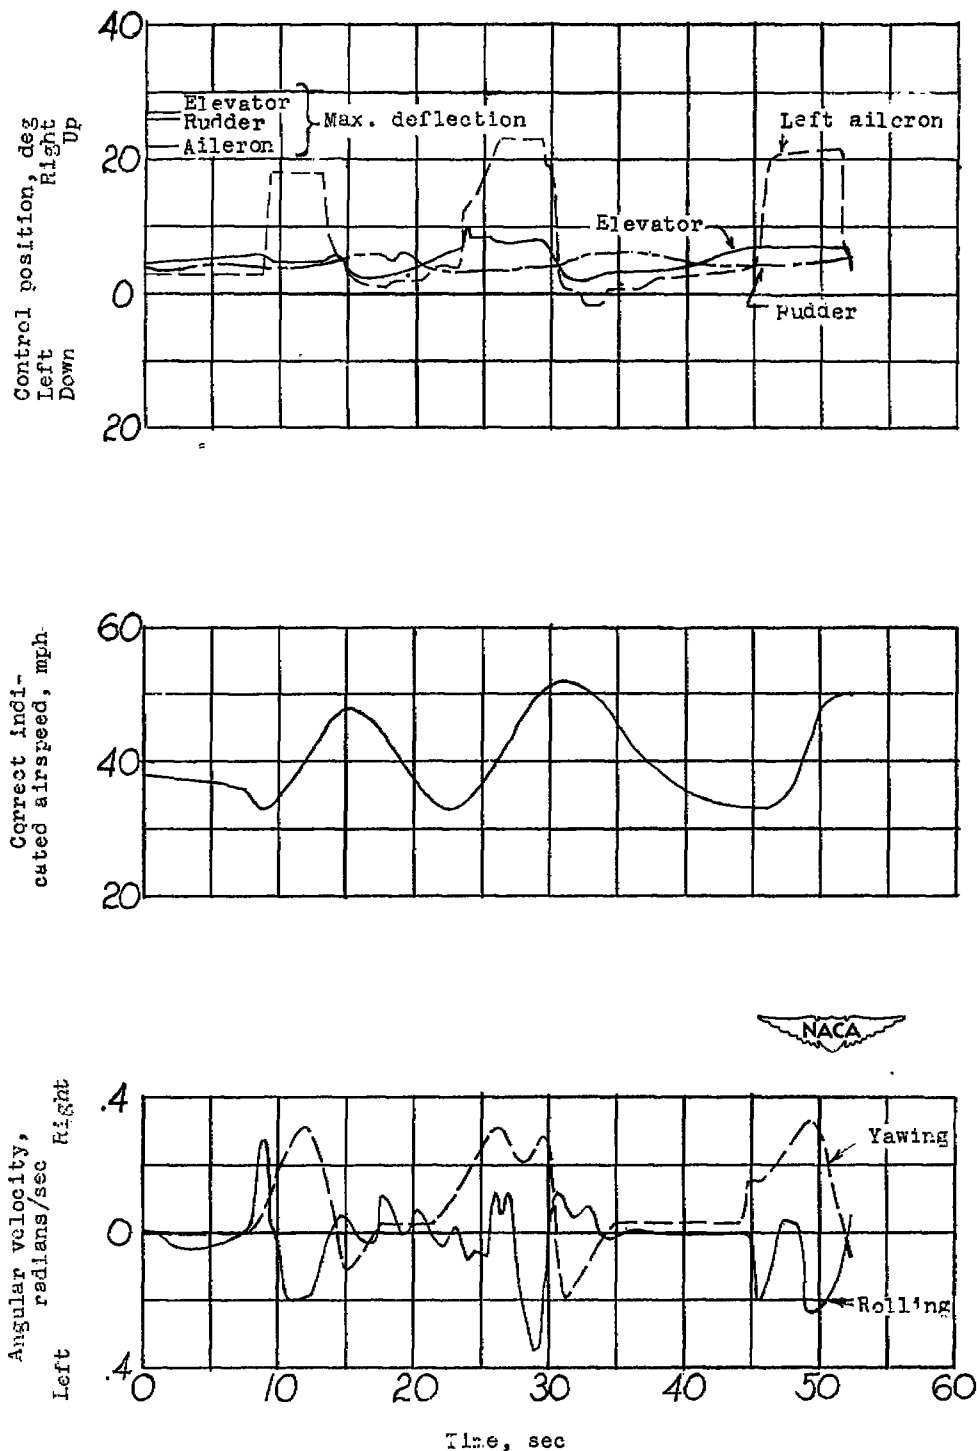
Figure 28.- Power-on stall approach. Elevators moved back until first indication of instability appeared, at which point the ailerons were used. Note the initial correct response in roll followed by a reversal of aileron effectiveness as the effect of adverse yaw predominated. Airplane 5.

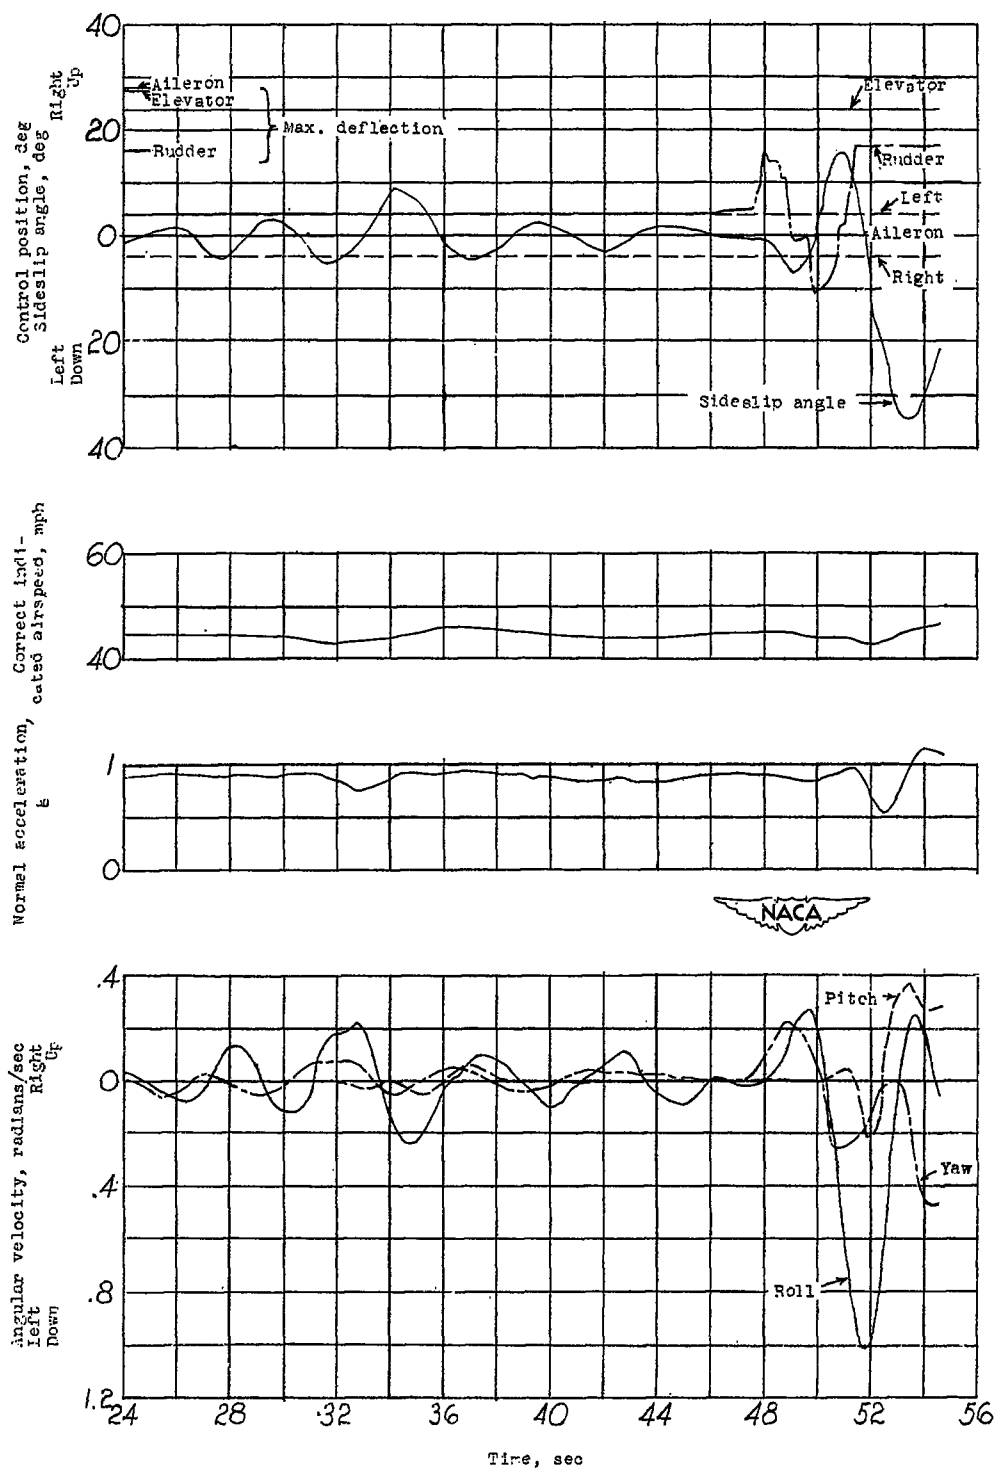
Figure 29.- Response to rudder with stick all the way back. Note continuous oscillation in pitch, roll, and yaw. Also note loss of control following use of rudder. Flaps up; power on; airplane 4.

by reversal of effectiveness as adverse yaw predominated. The response to the rudder with the stick all the way back in the stall is shown for airplane 4 in the flaps-up power-on condition in figure 29.

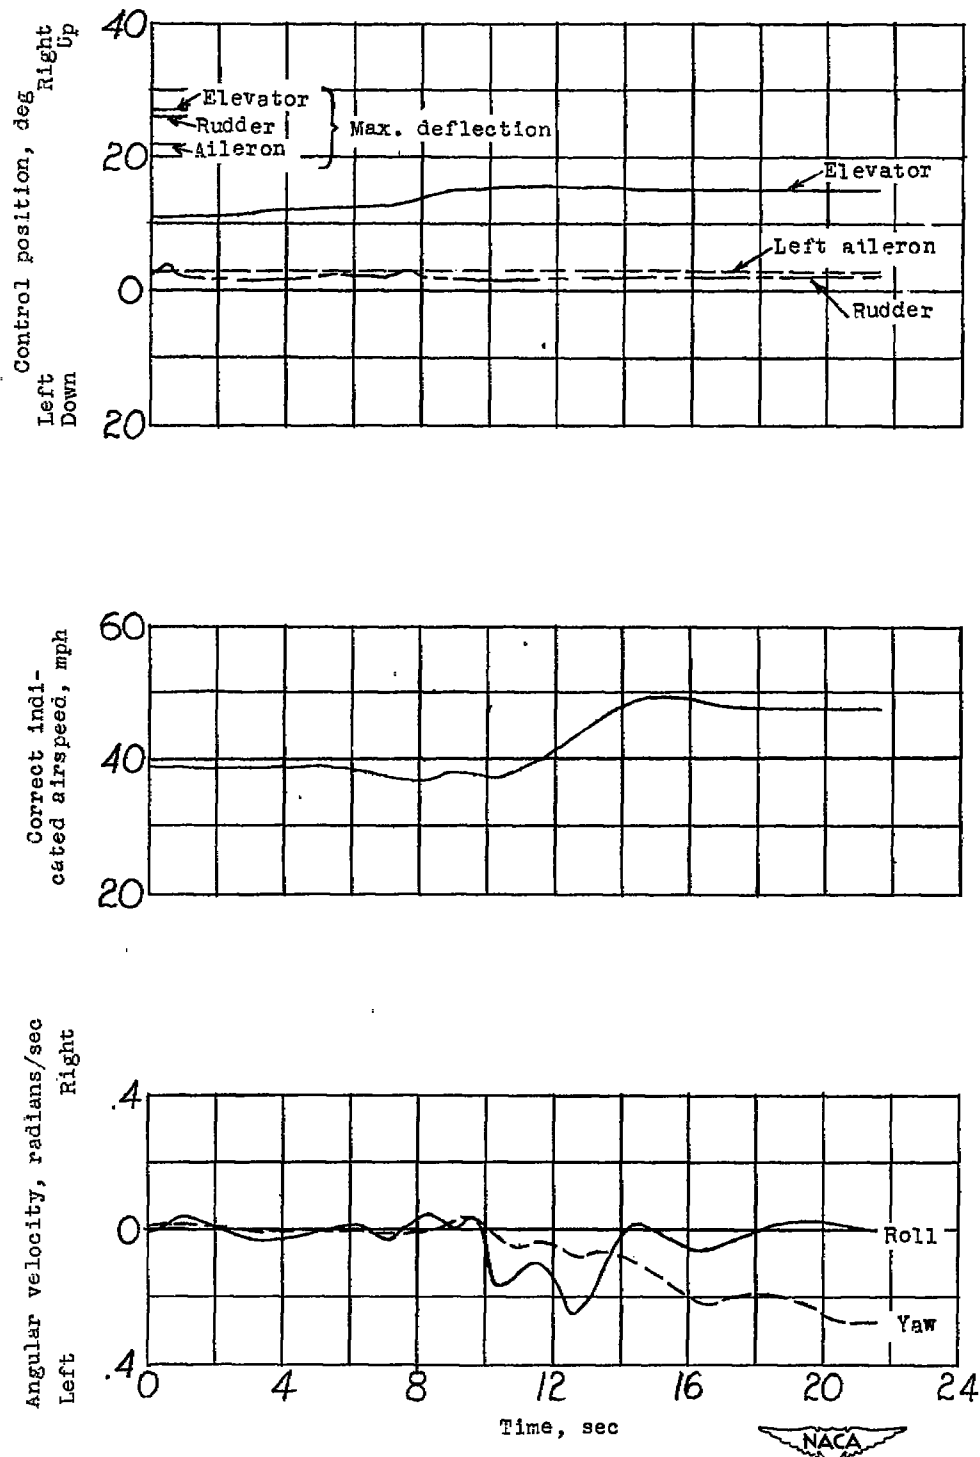
Figure 30.- Power-off stall approach from straight laterally level flight. Elevators were moved back until first indication of instability appeared, at which point all controls were held fixed. Note mild left roll not initiated by pilot which checked itself but resulted in a steady left turn. Airplane 5.

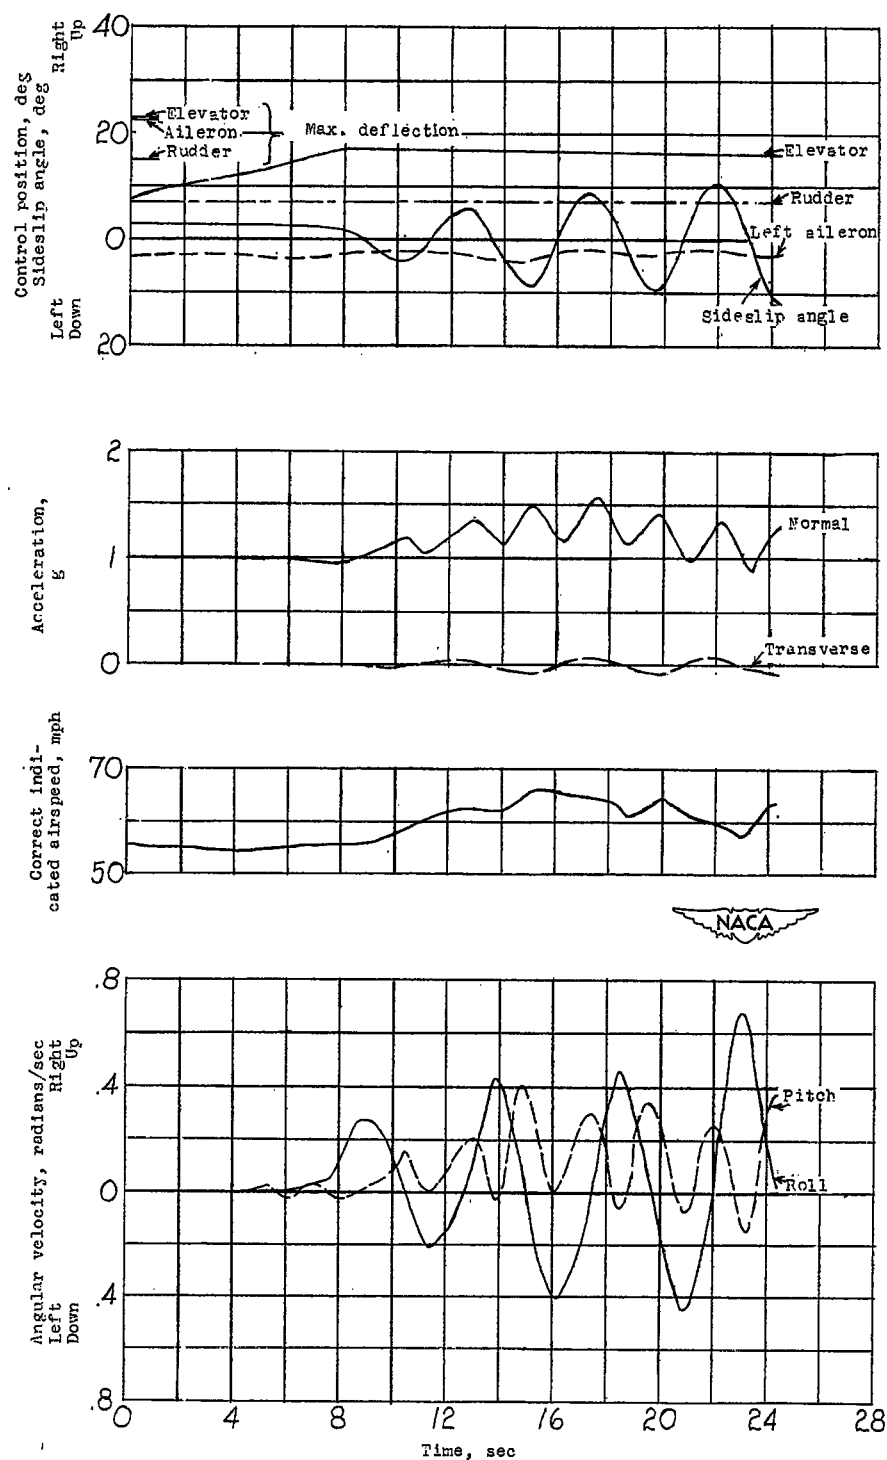
Figure 31.- Power-off stall from straight laterally level flight. When the elevators had been pulled back $3/4$ of full deflection, the other controls remaining essentially fixed, the ship developed a falling-leaf motion with increasing oscillations in roll and pitch. Note also the divergent oscillation in yaw as shown by the variation of angle of sideslip with time. Landing gear up; rearward center-of-gravity position; airplane 2.

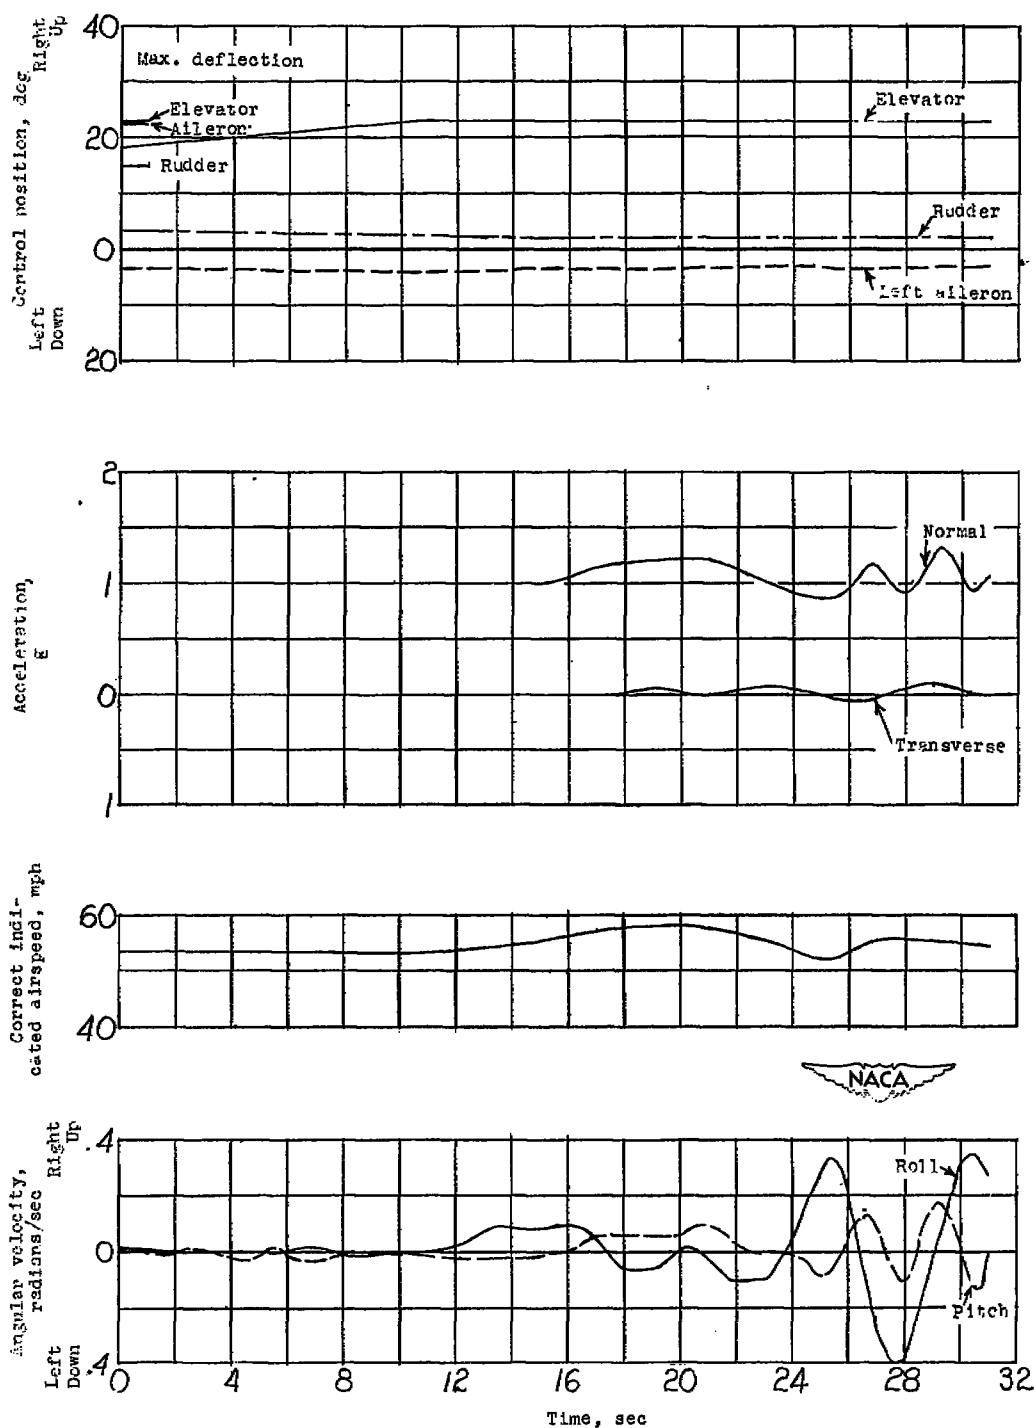
Figure 32.- Power-off stall approach from straight laterally level flight. Elevators were pulled up to their maximum deflections, rudder and ailerons remaining fixed. Note the motions in roll and pitch not initiated by the pilot which slowly increased in magnitude after the elevator had been fully deflected. Landing gear up; forward center-of-gravity position; airplane 2.

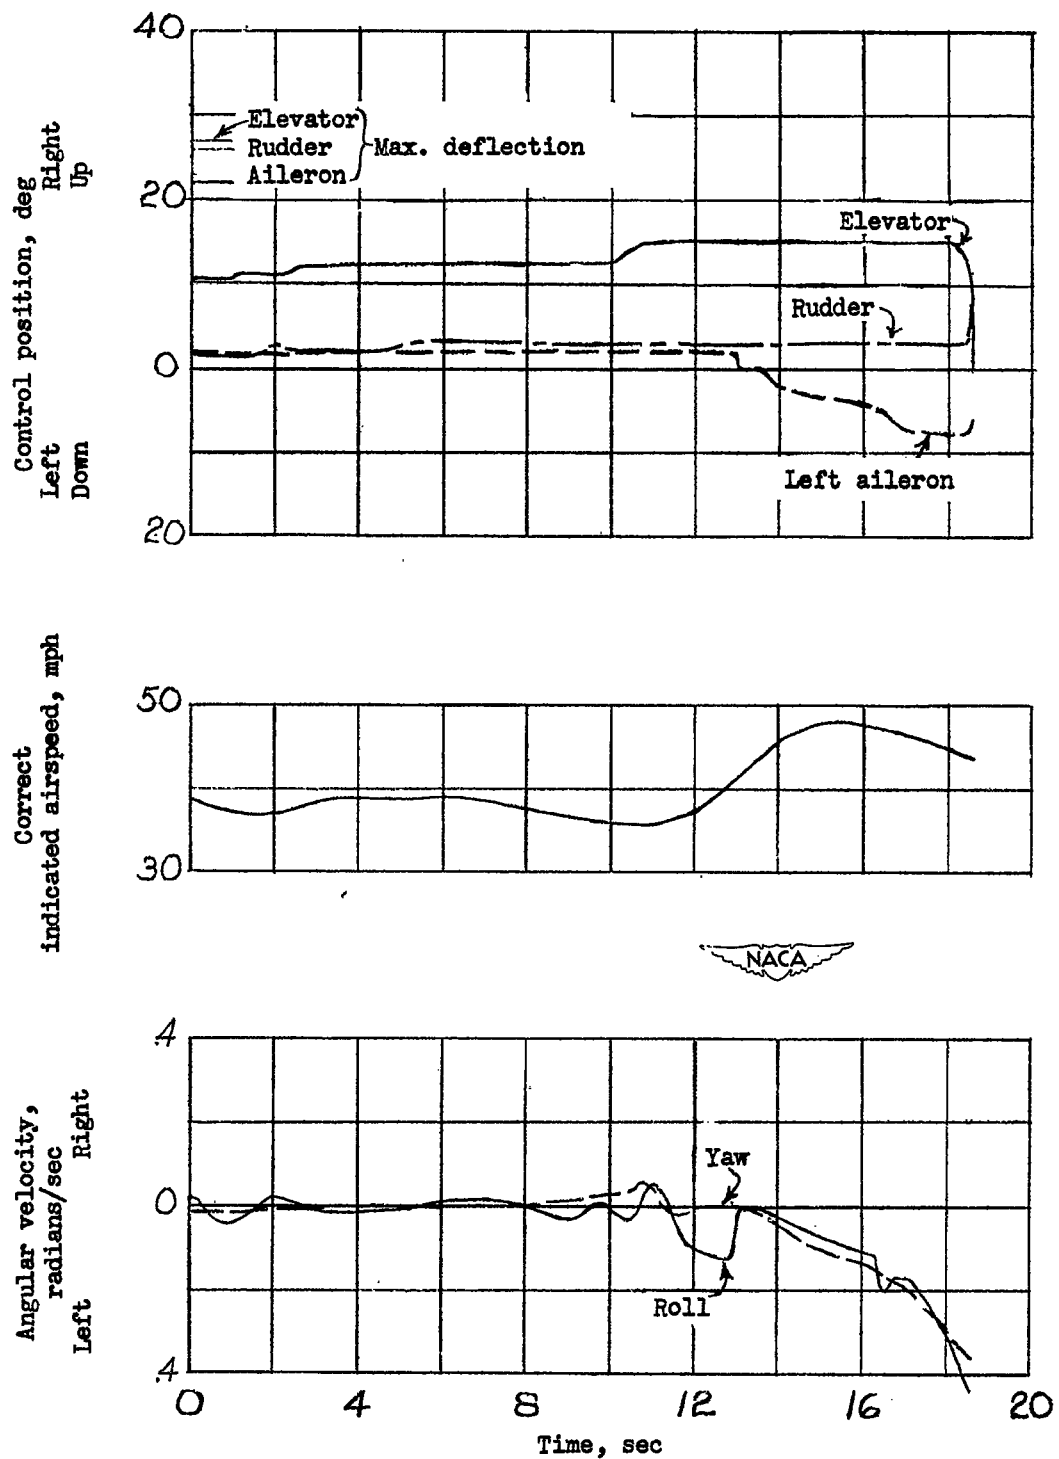
Figure 33.- Power-off stall approach. Elevator moved back until first indication of instability appeared, at which point the ailerons were used. The airplane rolled and yawed left against the applied aileron deflection. Airplane 5.

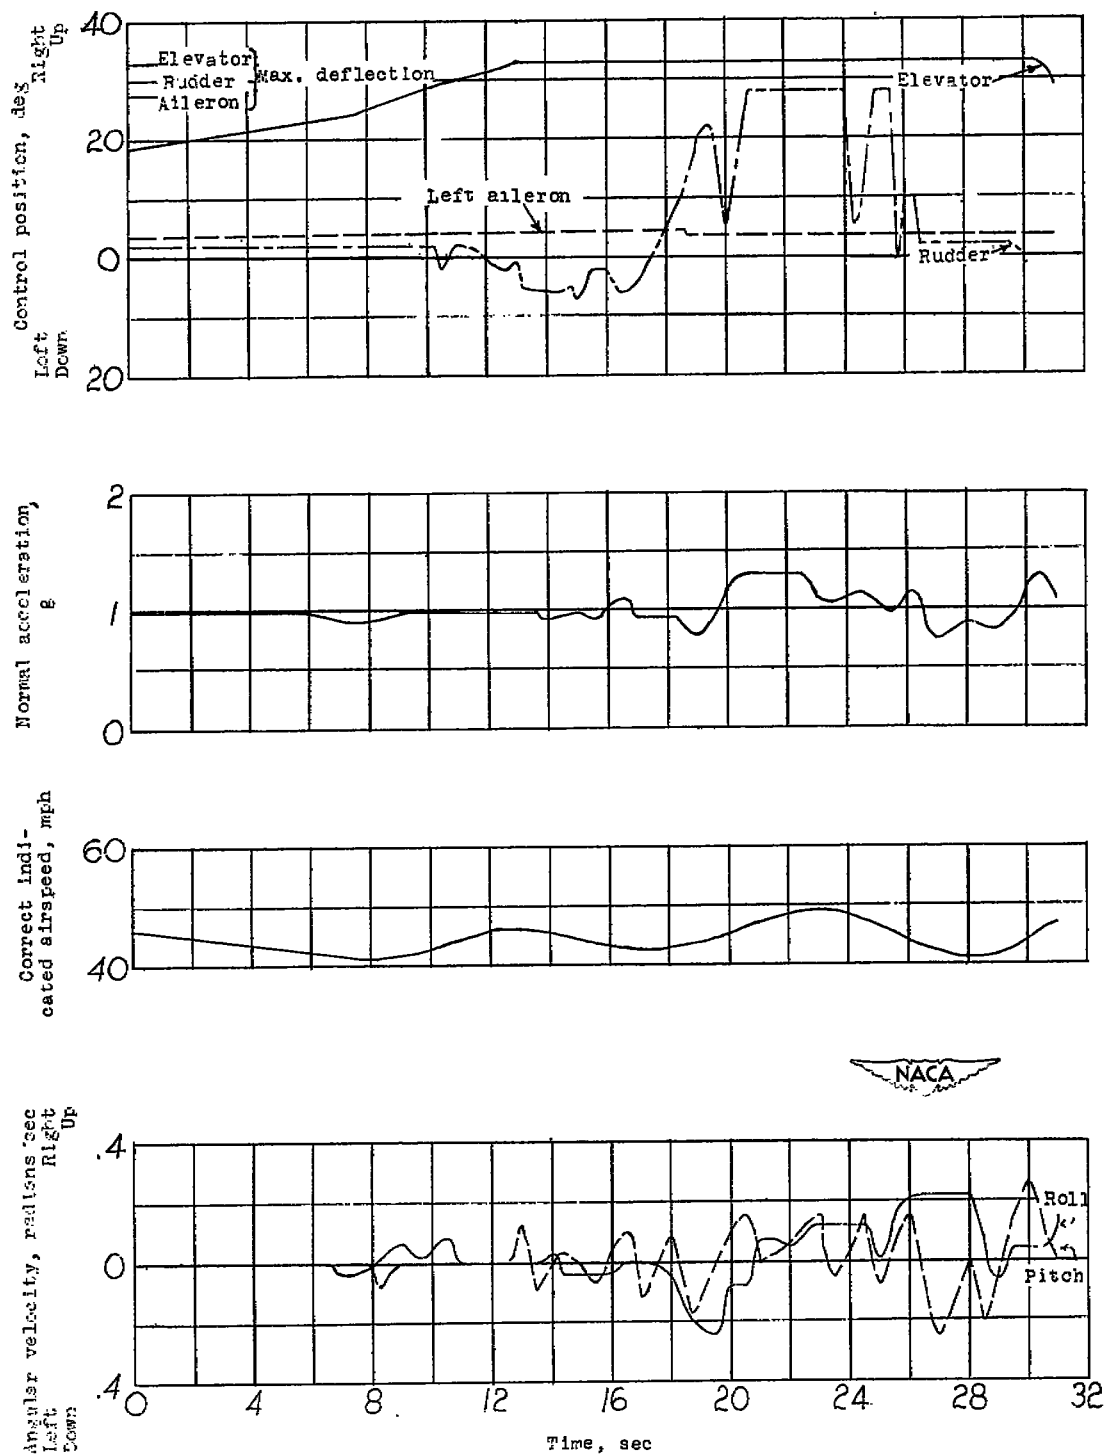
Figure 34.- Flight beyond the stall, power off, using rudder only. Note that pilot can keep violent rolling motion from developing by manipulation of the rudder with the stick all the way back. Airplane 1.

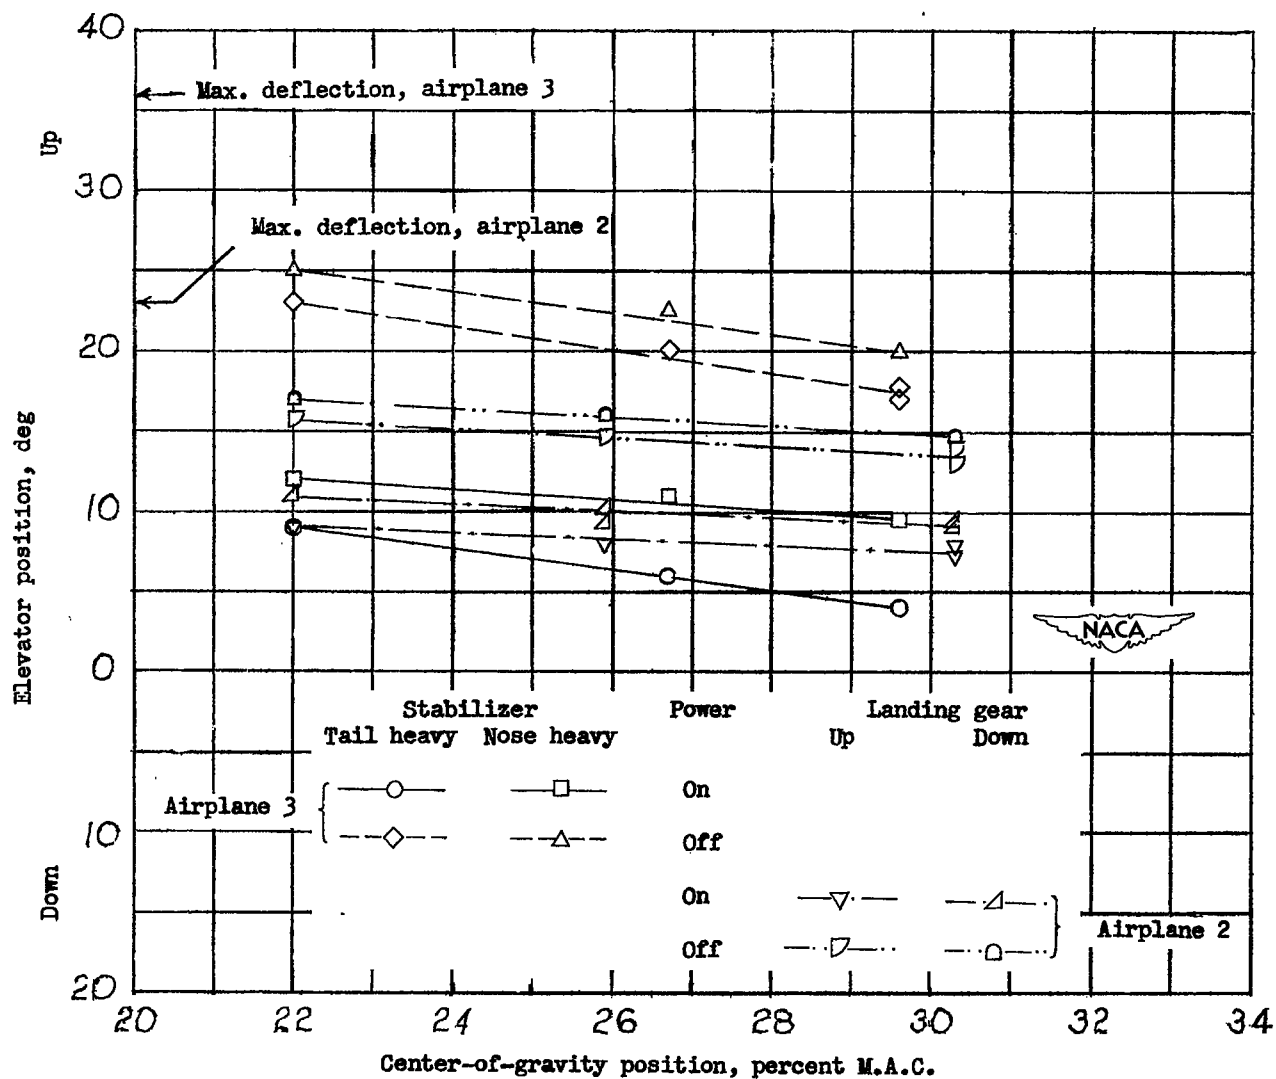
Figure 35.- Elevator positions required to stall at various center-of-gravity positions for different flight configurations. Elevator position measured from thrust axis; airplanes 2 and 3.

The effect of power on the elevator angle required to stall at different center-of-gravity positions is shown in figure 35 for airplanes 2 and 3. Airplane 2 showed the least effect of power on the elevator angles at which motions not initiated by the pilot first occurred, and airplane 3 showed the most effect of power of all the airplanes tested. The difference between elevator angles for the power-on and power-off conditions was of the order of 6° for airplane 2 and 13° for airplane 3 as shown in figure 35. Figure 35 also shows the effect of longitudinal trim for airplane 3 and landing-gear position for airplane 2.

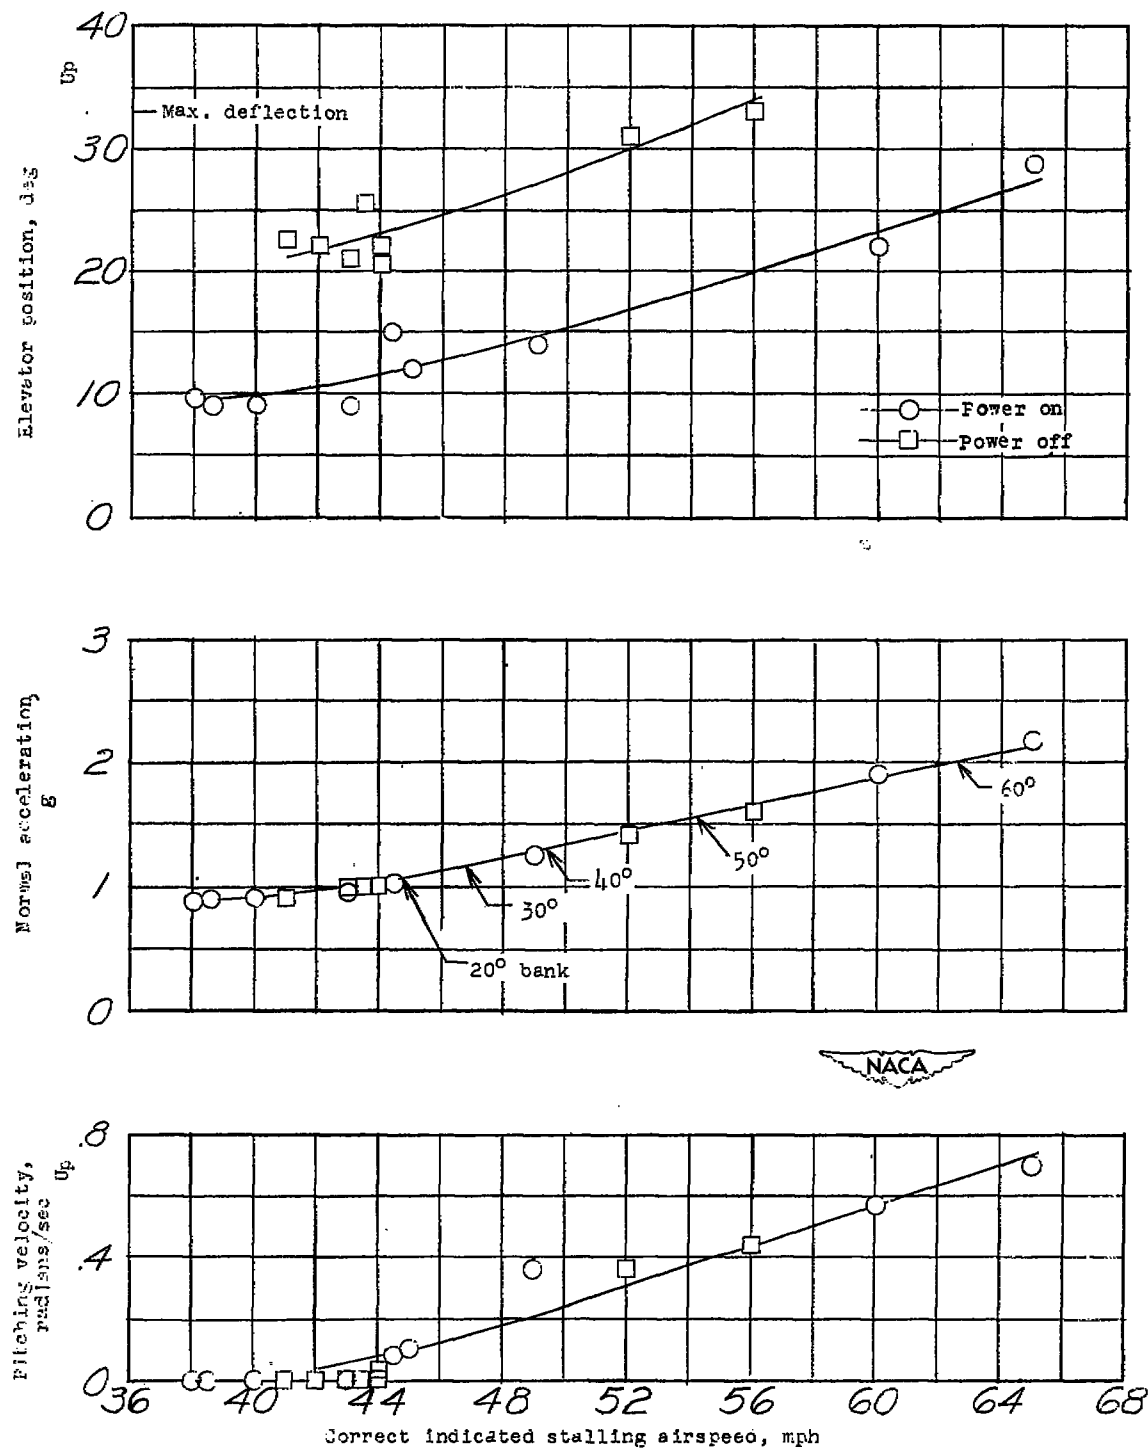
Figure 36.- Variation of elevator position, normal acceleration, and pitching velocity with indicated stalling airspeed in normal banked turns, power on and power off. Elevator position measured from thrust axis; airplane 1.

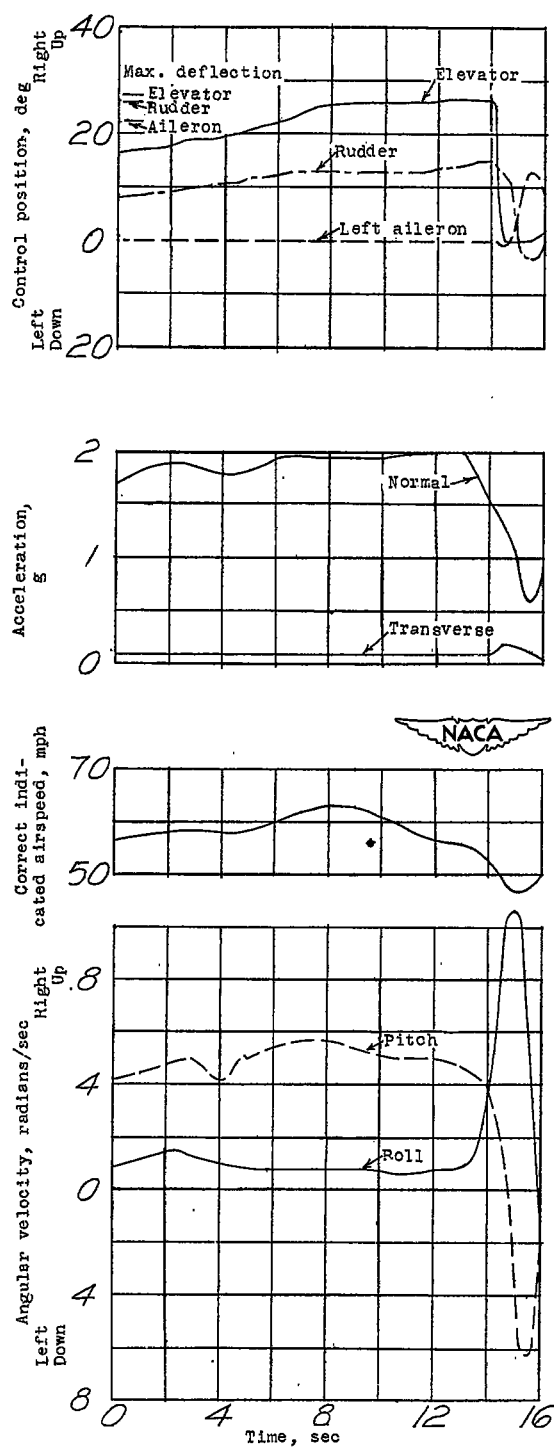
Figure 37.- Stall from a tight power-on left turn. Slipping into turn (as indicated by transverse acceleration) produced roll out of turn when instability occurred. The instability was relieved by moving the elevators down. Airplane 5.

A time history of a stall from a tight power-on left turn is shown in figure 37 for airplane 5. This figure shows that the airplane rolled out of the left turn when sideslip was carried. A power-on right turn in which the airplane again rolled out of the turn when sideslip was carried is shown in figure 38 for airplane 3. This characteristic was also quite typical of airplanes 1 and 5 in this condition. The initial roll-off was found to be either into or out of the turn, the direction depending on whether the airplane carried skid or sideslip, respectively. All the turns in airplanes 1 and 3 carried sideslip, as indicated by the transverse acceleration (plotted positive for acceleration to the left), and the downwind wing stalled first in every case so that the direction of initial roll-off was always out of the turn. When neither sideslipping nor skidding was present, airplane 5 tended, in most cases, to roll into the turn when instability occurred. Instability in this direction is considered a particularly dangerous condition because of the resulting attitude which makes recovery an acrobatic maneuver requiring considerable altitude.

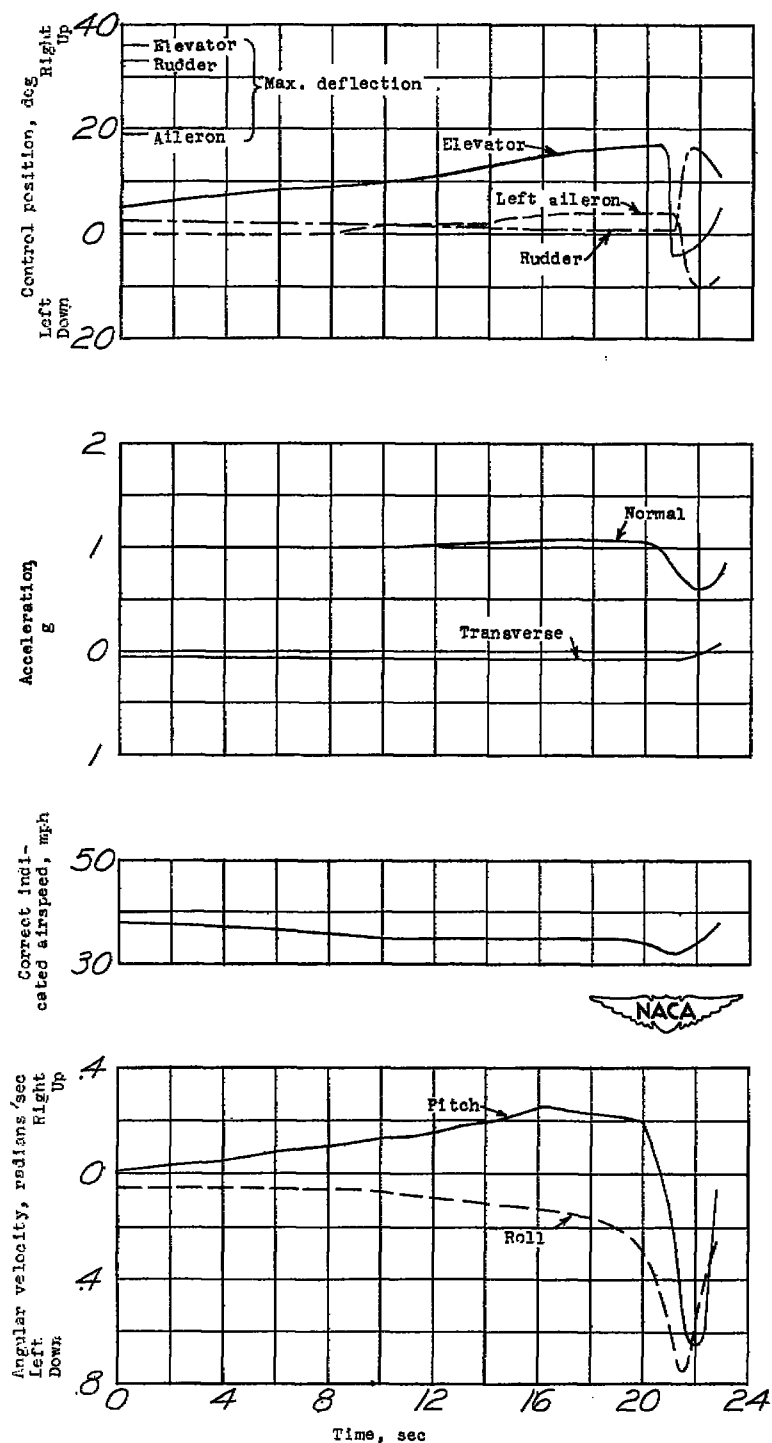
Figure 38.- Stall from a power-on right turn. Note that aileron was held out of the turn and sideslip occurred into the turn. Elevators were slowly pulled up, lateral instability developing at about 16 seconds and resulting in a roll-off out of the turn. Airplane 3.

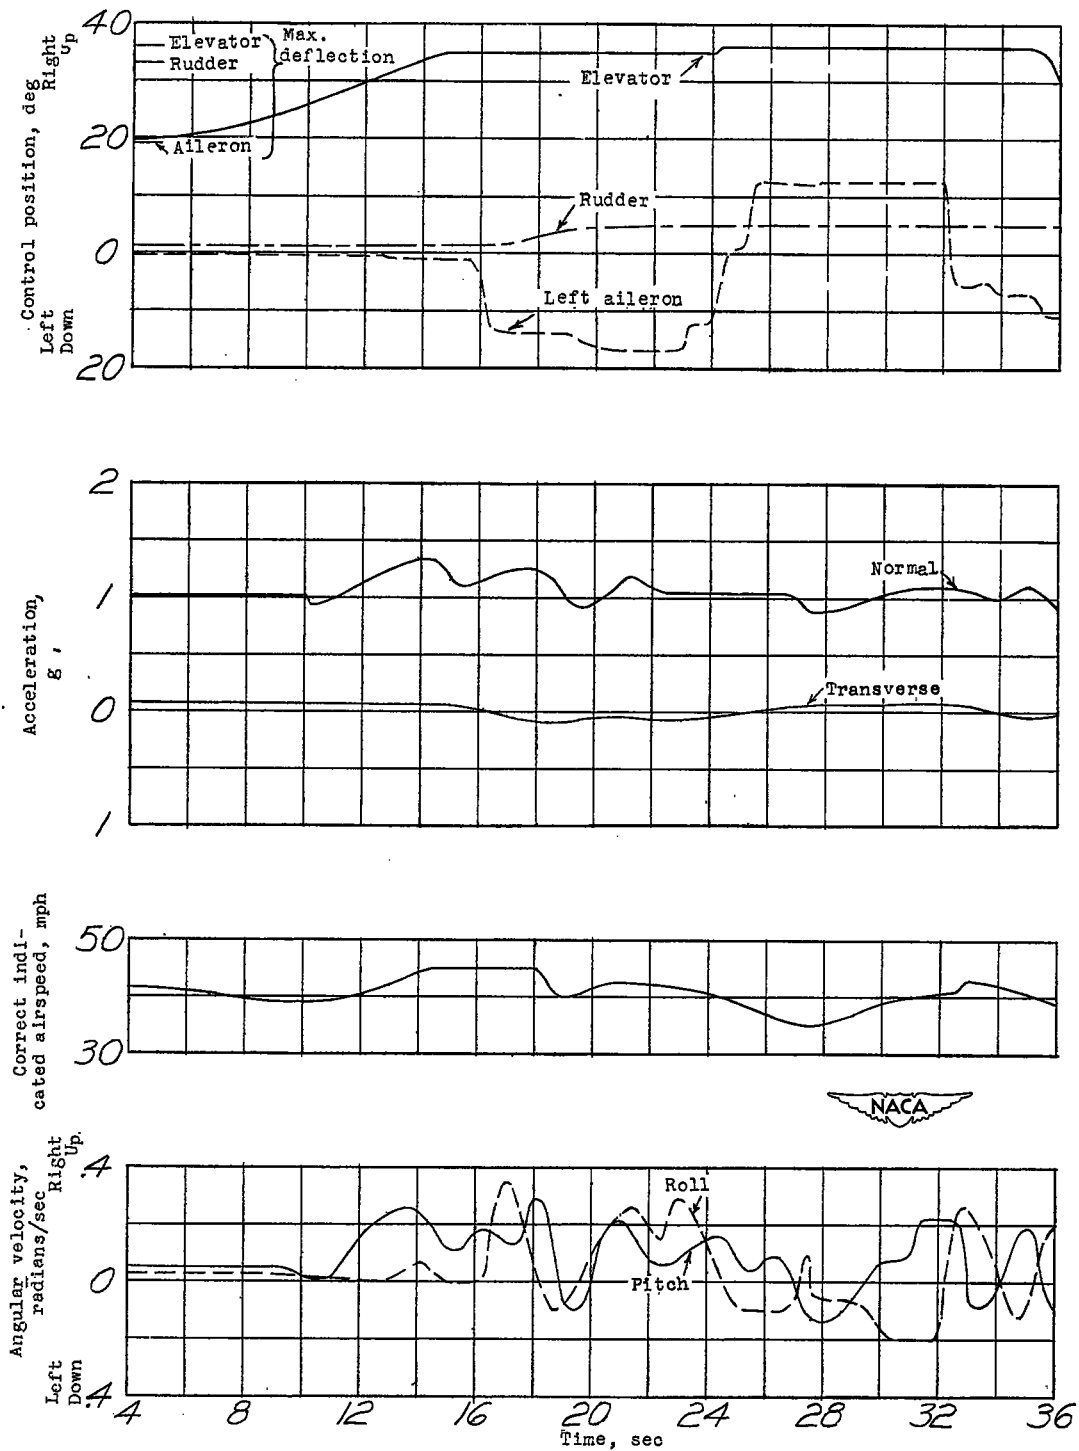
Figure 39.- Attempt to produce power-off stall in left turn. No instability occurs with the elevators full up. Controlled aileron rolls were made to right and left with the elevator remaining fully deflected. Airplane 3.

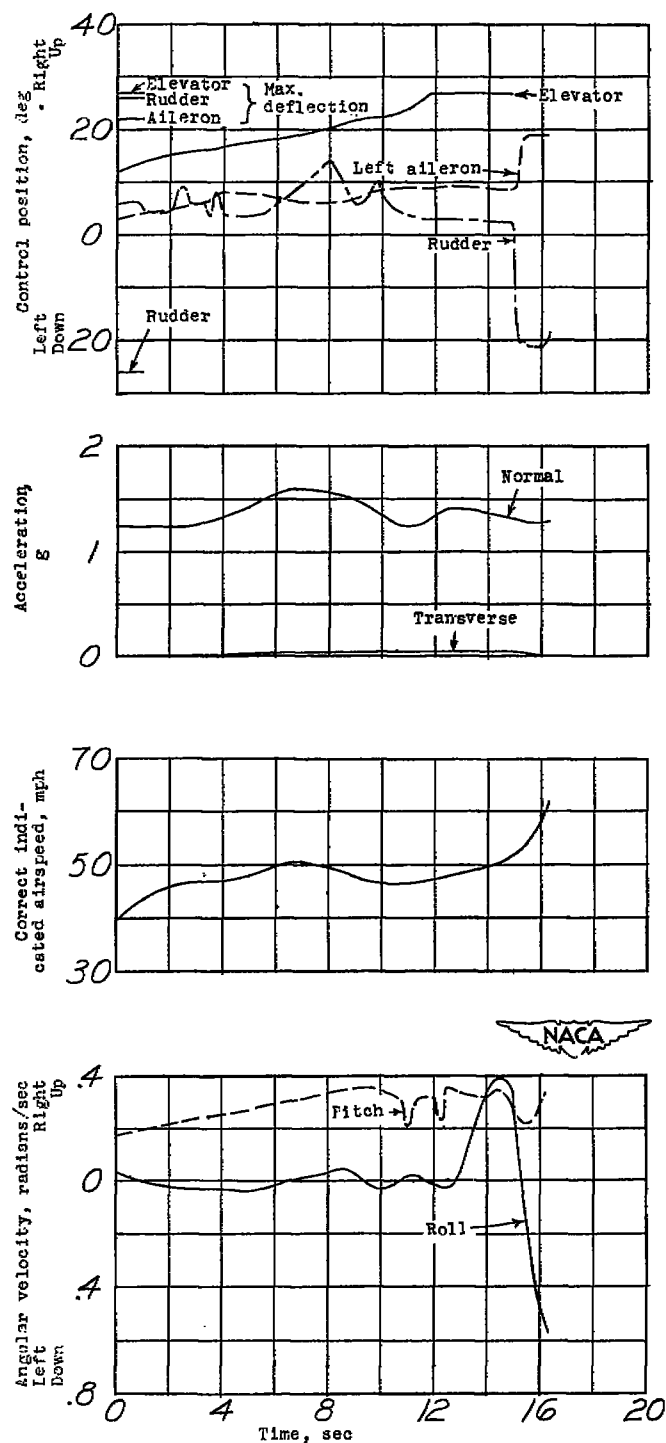
Figure 40.- Stall from a power-off right turn. Transverse acceleration indicates skidding out of turn. As a result, the airplane rolled into turn when instability developed. Note small pitching motions prior to the roll-off which were not initiated by pilot. Airplane 5.

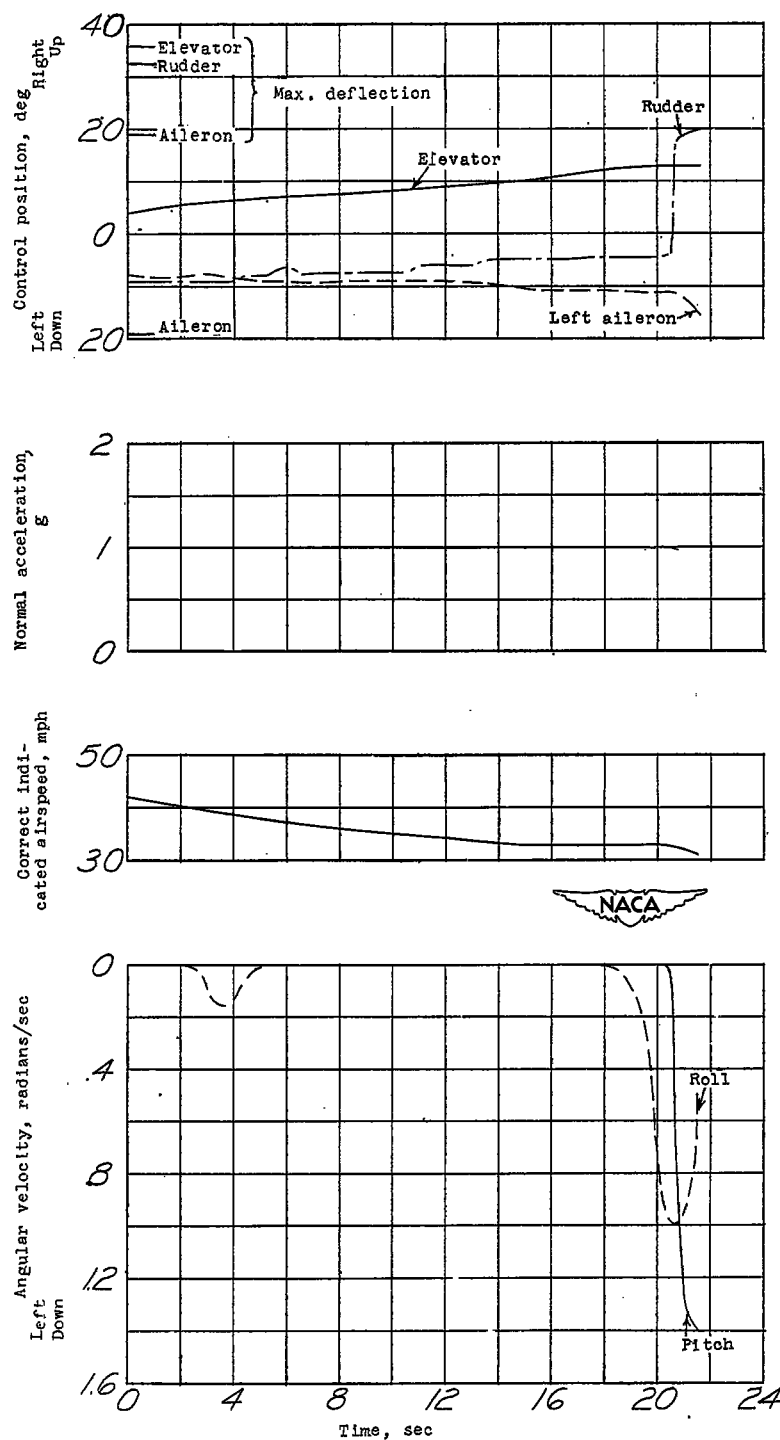
Figure 41.- Stall from a 20° right sideslip with power on. Airplane spun out of sideslip when lateral instability occurred. Note large values of pitching velocity attained. Airplane 3.

Stalls from steady yawed flight.— Stalls from steady yawed flight were produced in airplane 3 to compare the resulting stalling characteristics with those experienced under unyawed conditions with particular regard to studying the effects of carrying sideslip or skid in turning flight. These stalls were executed by the usual gradual reduction in airspeed, but the rudder and ailerons were manipulated to maintain a steady yawed condition. The direction of roll-off and the violence of the resulting instability were studied. The results are presented in the form of time histories in figures 41 to 43.

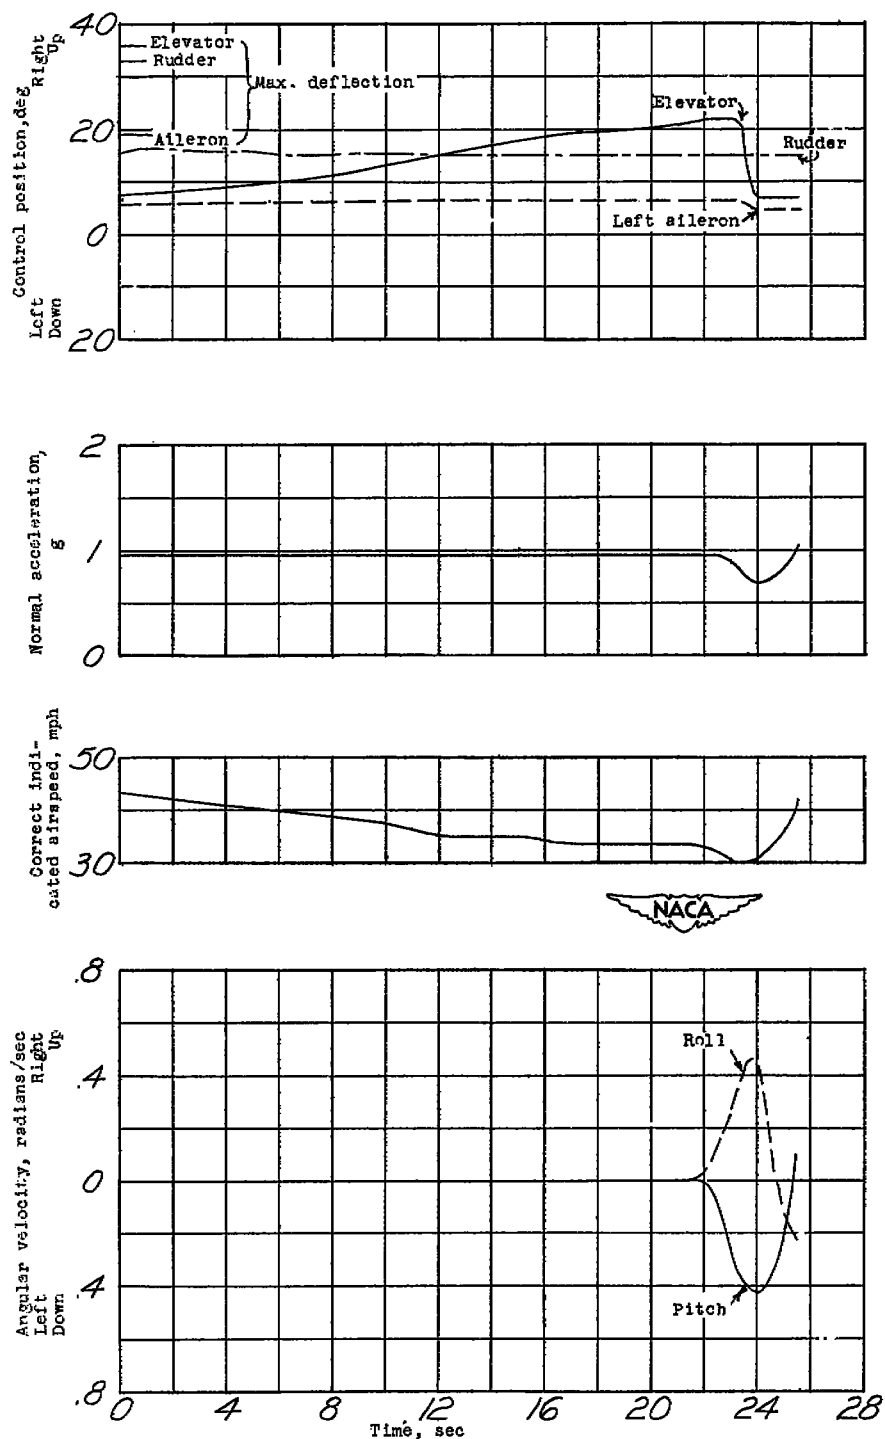
Figure 42.- Stall from a 20° left sideslip with power on. Airplane spun out of sideslip when lateral instability occurred. Instability was checked by pushing the elevators down. Airplane 3.
